**PERFORMANCE OF REHABILITATED  
ASPHALT CONCRETE PAVEMENTS  
IN THE LTPP EXPERIMENTS -  
DATA COLLECTED THROUGH  
FEBRUARY 1997**

**January 2000**

1. Report No. FHWA-RD-99-00-029		2. Government Accession No.		3. Recipient's Catalog No.	
4. Title and Subtitle PERFORMANCE OF REHABILITATED ASPHALT CONCRETE PAVEMENTS IN THE LTPP EXPERIMENTS - DATA COLLECTED THROUGH FEBRUARY 1997				5. Report Date

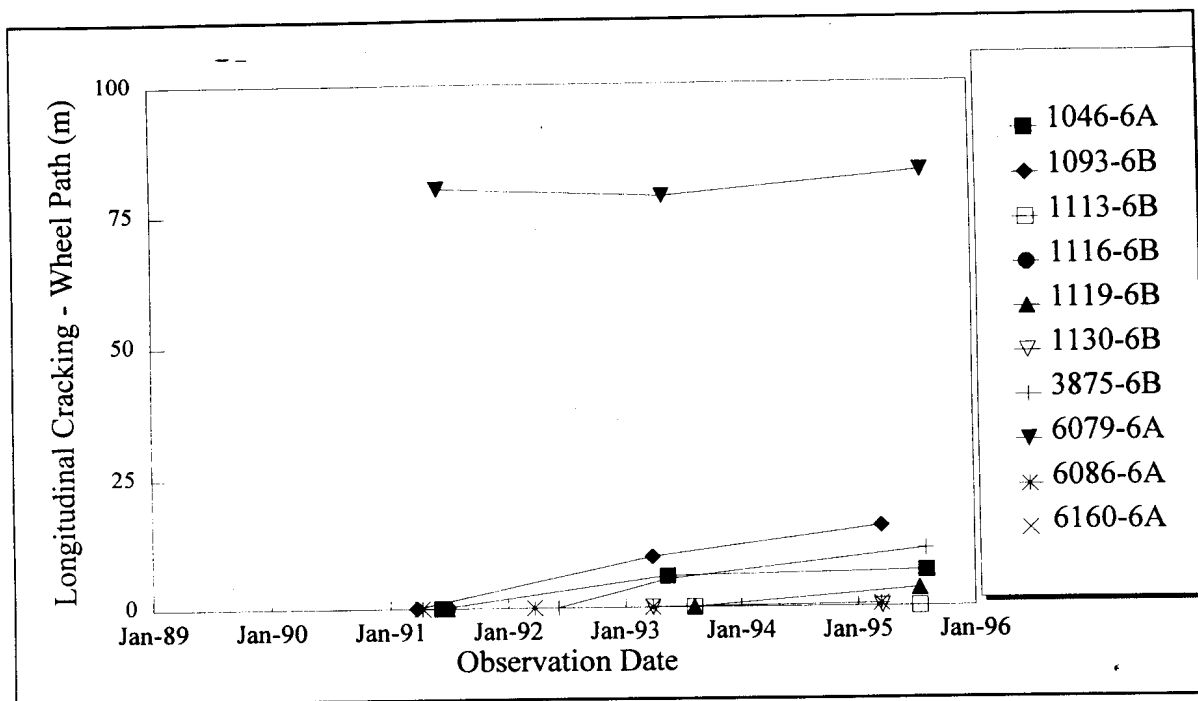
Figure 26. Longitudinal cracking in wheel paths in Texas GPS-6 test sections.

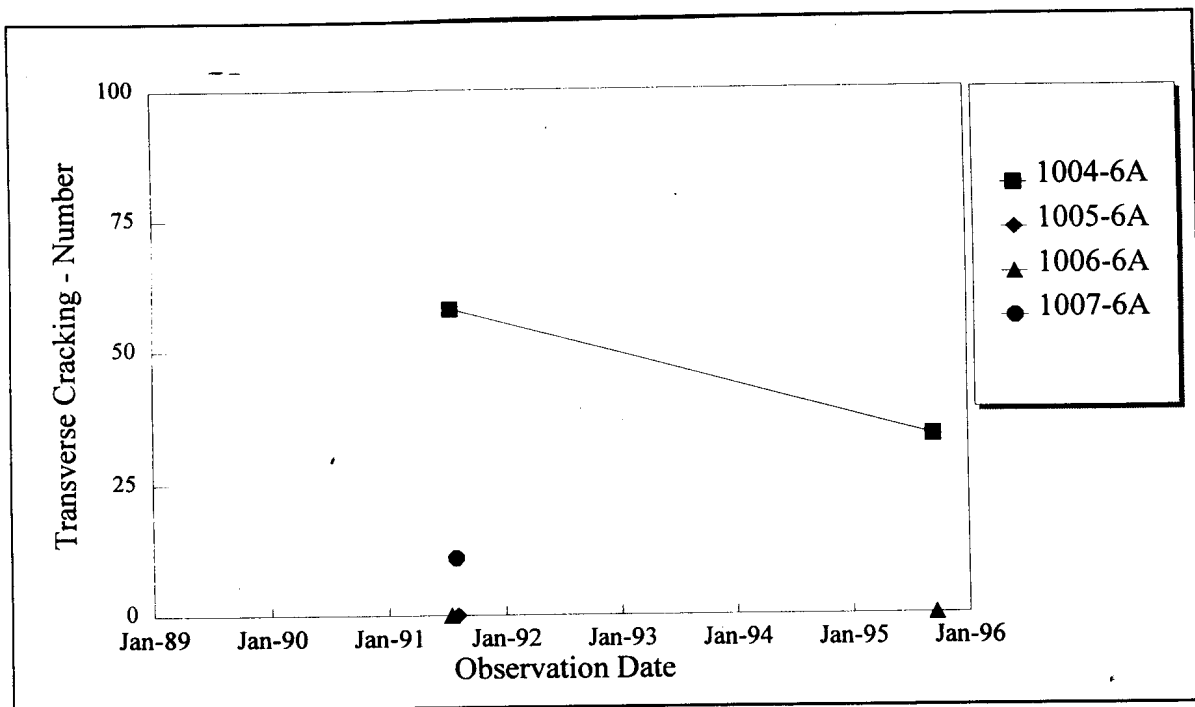
**Figure 39. Number of transverse cracks in Utah GPS-6 test sections.**

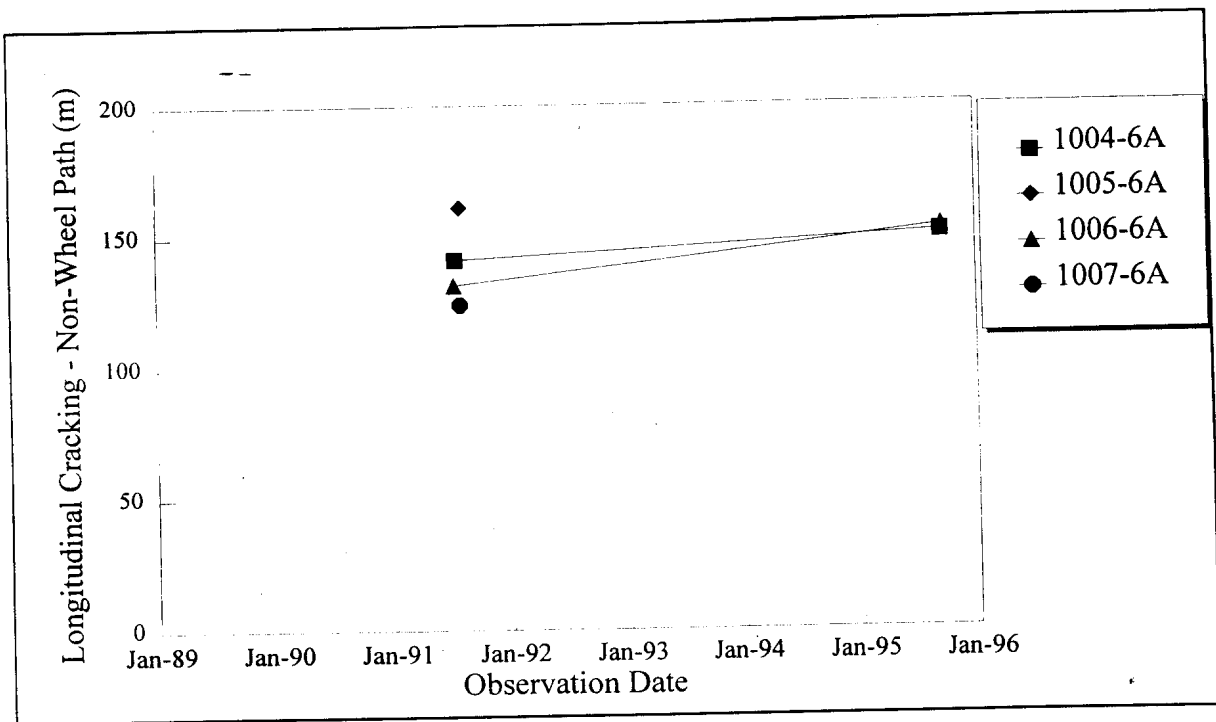
**Figure 48. Longitudinal cracking not in wheel path in Utah GPS-6 test sections.**
